Rebuilding Updates

July 2010

The major causes of destruction in Haiti

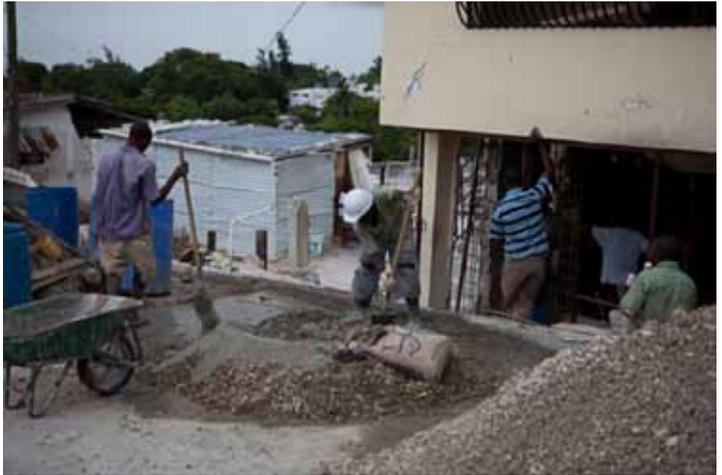
Poorly graded sand and aggregate will result in poor quality concrete. Here it is being used to pour thin columns to support the failing damaged concrete structure above.

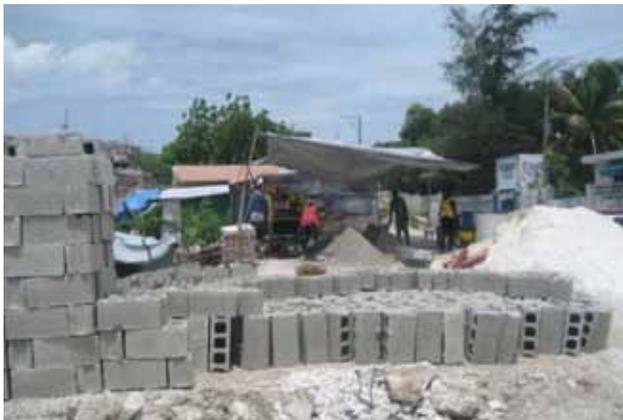
Block being manufactured with little quality control, poor curing, and inferior raw materials (sand/aggregate). If provided with properly graded and tested raw materials, clean water and education about proper curing and handling, strength of the block can be greatly improved at minimal expense.

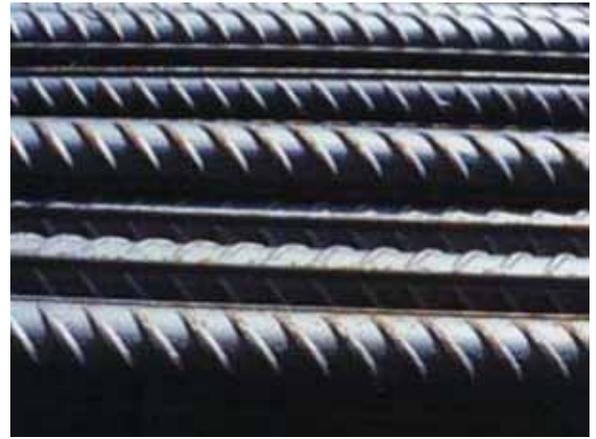
Here is a photo of “deformed rebar” showing ribs which allow the concrete to grip the steel for structural integrity. Unfortunately much of the rebar used in Haiti is smooth and therefore the concrete fails when the bar breaks away from the concrete. What is the cost of proper rebar? What is the cost of not using the right materials?

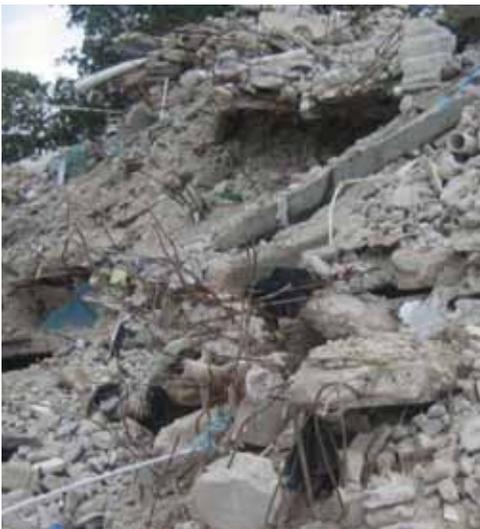
Photo showing how easily the smooth rebar broke away from the concrete. Well adhered deformed bar would have pieces of concrete sticking to entire length even after such a collapse. Without connection to the concrete, the steel fails to perform its job.

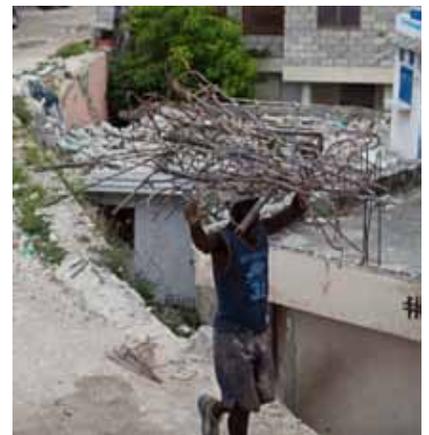
This salvaged bar, much of it smooth, will soon be part of the next building. Steps need to be taken to make proper materials readily available.

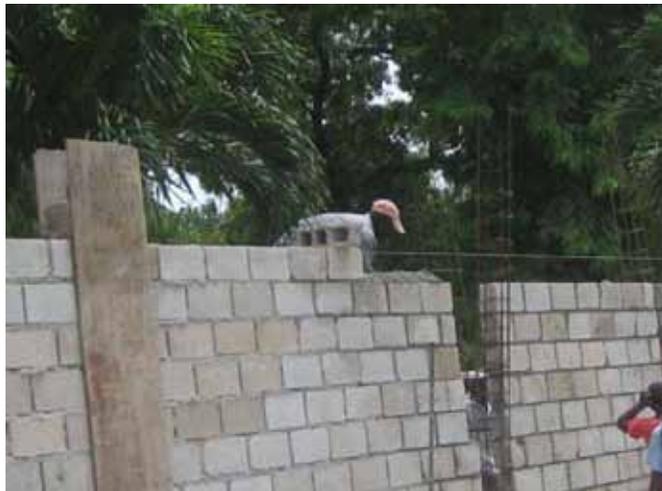
Here is a typical wall construction in Haiti: Widely spaced vertical reinforcing, no horizontal reinforcing and block is left hollow except at the reinforcing. The addition of a proper depth foundation, rebar reinforced bond-beams, truss type horizontal reinforcing in every other course of block, and closely spaced vertical bars in grout-filled cores would make a world of difference in the strength of these walls. This is typical wall construction throughout Haiti whether it is for a security wall, or a building wall supporting roofs and floors above.

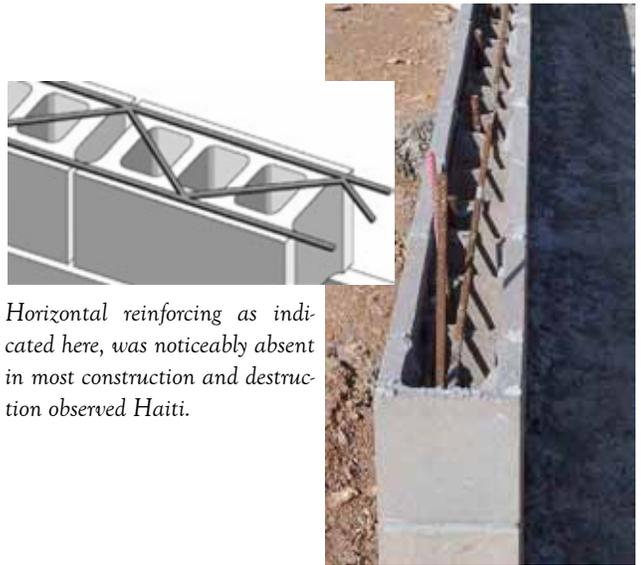
Horizontal reinforcing as indicated here, was noticeably absent in most construction and destruction observed Haiti.

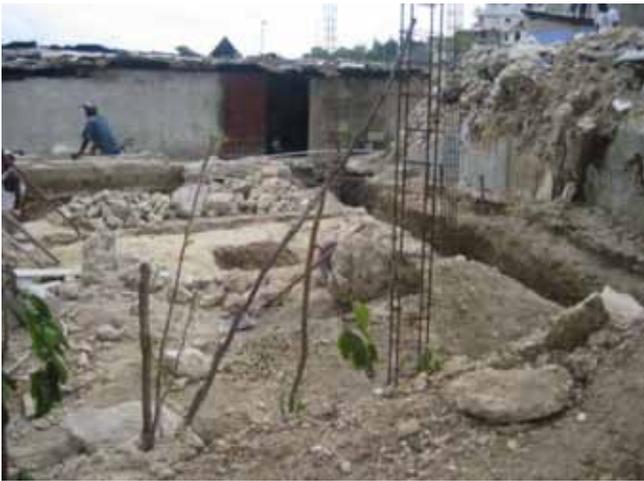
New construction being set up for a home with typical widely spaced and inadequate vertical reinforcement.

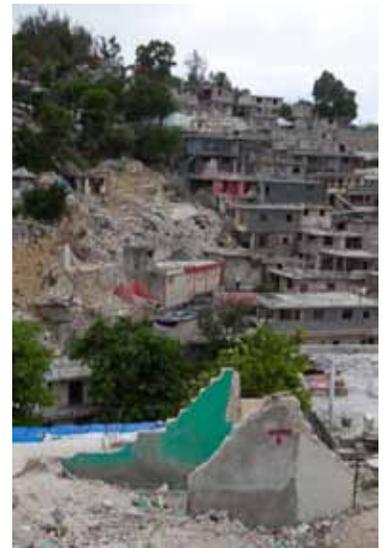
Steep slopes are not conducive to safe construction

- Create land use codes that prevent construction in unsuitable locations: Steep slopes, the bottoms of storm drainage paths and ravines, and unstable soil areas are simply not good places to build. Comprehensive land use zoning can quickly be implemented to identify unsuitable areas, and as debris is cleared, some areas will need to be put off-limits to new construction. Local governments will have to work at methodically relocating populations remaining in these areas.

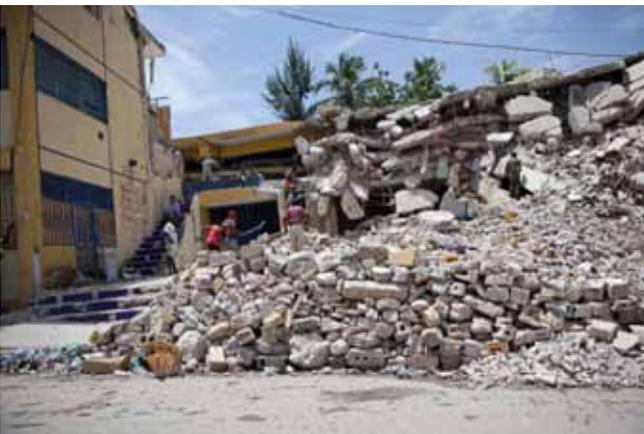
Large buildings such as this pancaked structure which was once about 4 stories tall are difficult and expensive to build to meet earthquake standards. It is imperative if such structures are to be built, that they must be required to meet international codes and have strict quality control and inspection standards during construction. Imagine the lives lost in just this one building.
